(Bulletin for Statehouse, Capitol Mall Employees October 29, 2001)

Department of Administration
Construction Update No. 12

Replacing Old Mortar On Statehouse Exterior Requires “Step by Step” Process by Workers

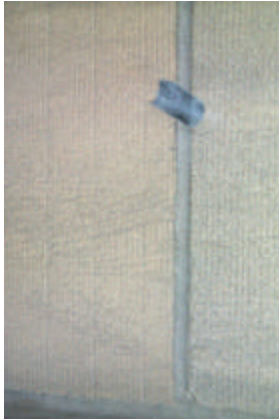
Step 1: Tape marks joint needing repair.

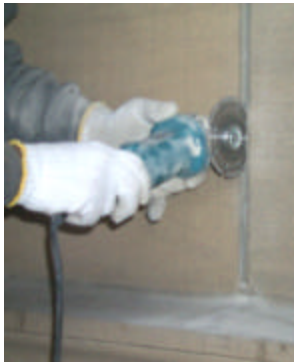
Step 2: Cutting a groove in the old mortar.

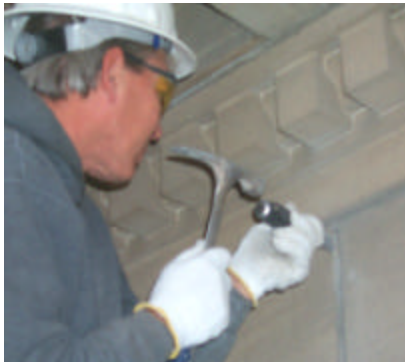
Step 3: Chiseling away the Mortar from joint area.

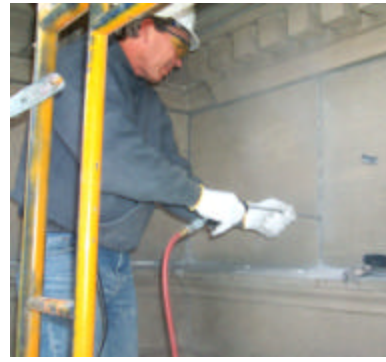
Step 4: Using a compressor, the worker blows out old dust.

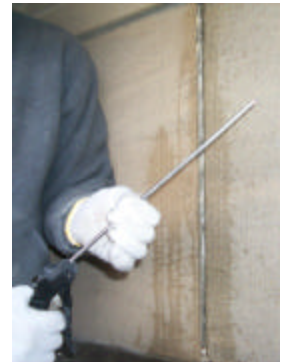
Step. 5: Depth of joint evaluated.
